CONDITION OF CONCERN

On Mazdaspeed6 and RX-8 vehicles, improper installation of the fuel pump mounting rings may lead to cracking of the rings, causing fuel leakage. In addition, on RX-8 vehicles, due to insufficient heat resistance at the top side of the fuel tank, the fuel pump mounting rings may deteriorate due to heat exposure from the engine and exhaust pipe which may also lead to cracking of the rings, causing fuel leakage. Fuel leakage may result in increased risk of fire in the presence of an ignition source near the vehicle.

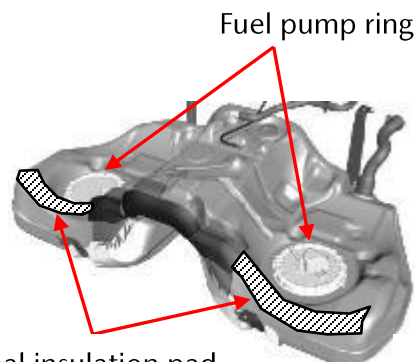
Fuel Tank (RX-8)

Thermal insulation pad

New fuel pump mounting rings will be installed on Mazdaspeed6 and RX-8 vehicles. In addition, thermal insulation pad will be added to the fuel tank on RX-8 vehicles.
